Sacramento River Flood Control System Evaluation
Initial Appraisal Report - Upper Sacramento Area

**BASIS OF DESIGN
GEOTECHNICAL EVALUATION OF LEVEES
FOR
SACRAMENTO RIVER FLOOD CONTROL SYSTEM EVALUATION
UPPER SACRAMENTO AREA - PHASE V**

February 1993

**PREPARED BY
SOIL DESIGN SECTION, GEOTECHNICAL BRANCH
U.S. ARMY ENGINEER DISTRICT, SACRAMENTO
CORPS OF ENGINEERS**

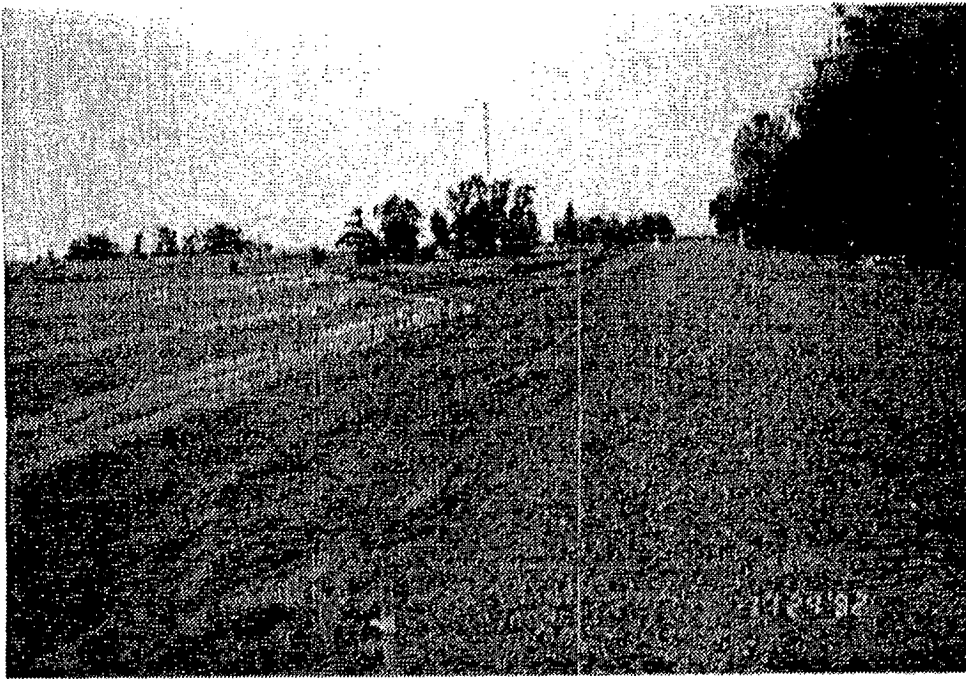
Site 1 is about 3 miles (15,700 feet) in length and extends from R.M. 92.7 upstream to 96.0 (Location, Plate 2, and Profile, Plate 27). See photos 1 and 2. It is located between Fourmile Bend and Victor Bend. This is a reported seepage area. However, during the field inspection, indications of past seepage in this area were not apparent. The levee soils in this area are composed predominantly of clean sand with fines content less than 12 percent. However, two banks failed during June 1992, approximately 8,000 feet south of site 1. The bank failure at R.M. 90.4 is about 110 feet in length, and the bank failure at R.M. 90.9 is approximately 225 feet in length. Existing vegetation has collapsed with the berm. What remains of the berm is the 10-foot fire break. The probable cause of these bank failures is seepage from the large landside irrigation ditch, which aggravated stability of the steep riverside berm. The seepage from the irrigation ditch in this area has saturated the foundation beneath the waterside berm and significantly decreased the shear strength of the underlying silty clay material, thereby triggering the berm failure. Full bank rock revetment was recommended and was constructed at R.M. 90.4 and R.M. 90.9 in late 1992 and early 1993.

The levee at Site 1 consists of loose sand. This material is susceptible to seepage. However, based on levee geometry, this levee section is not considered critical. The levee crown width is quite large varying from approximately 23 to 50 feet. The landside slope is relatively flat at IV on 2.4H to 2.7H at boring locations 2F-92-30, -31 and -32 (Photos 1 and 2). The levee foundation soil along this area consists mainly of silt and clay. It is believed that the seepage in this area is primarily of nuisance variety and does not pose any major risk to levee stability. Therefore, no reconstruction is recommended at this site.

Photo 1: Site 1 - Landside slope just upstream of boring 2F-92-31.
(Nov 24, 1992)

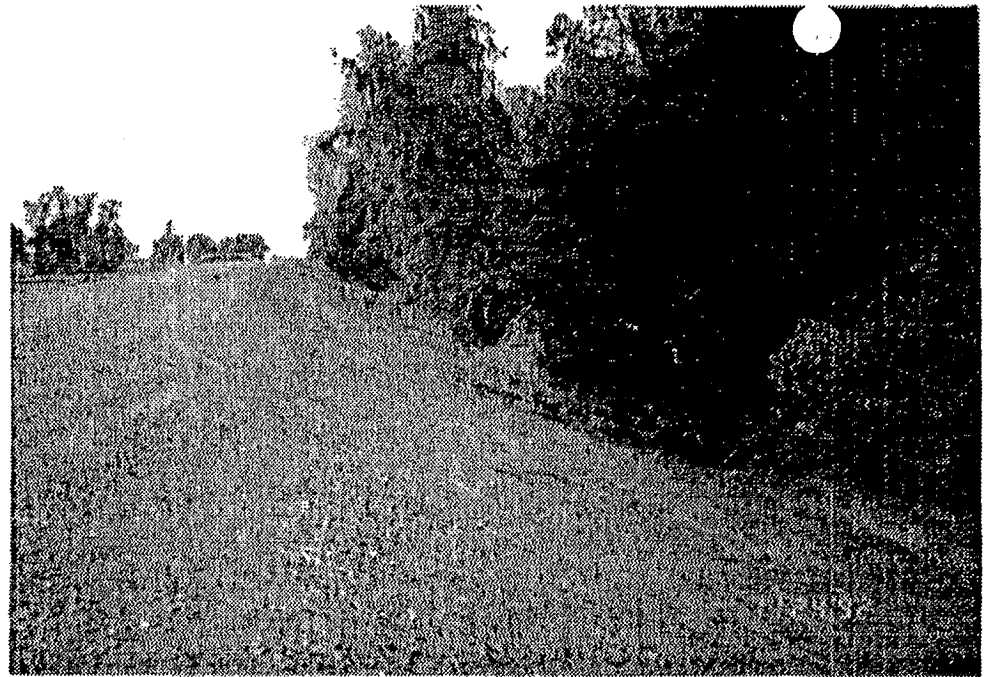
Photo 2: Site 1 - Looking upstream along waterside slope from boring 2F-92-31.
(Nov. 24, 1992)

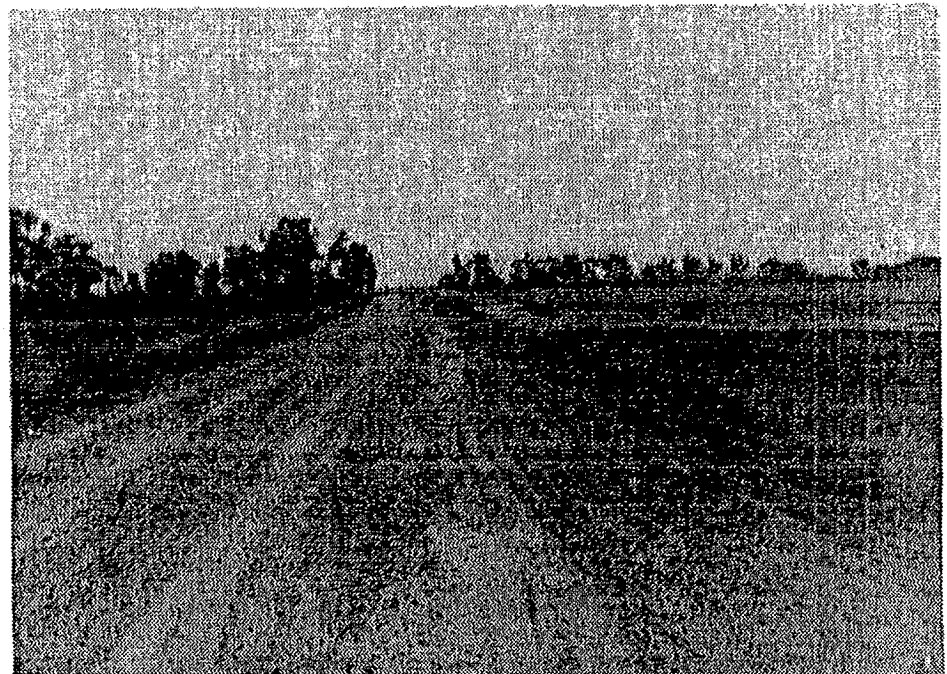
Site 2 was identified as a seepage site. Exploration data indicate levee conditions are susceptible to seepage. As can be seen on the levee profiles on Plate 29, the levee soil consists primarily of clean sand (boring 2F-92-28 and 2F-92-29). At the locations where the levee soil is primarily clean sand, the landside slope varies from about IV on 3.5 to 4.1H (Photos 3 and 4).

Photo 4: Site 2 - Typical levee at this site. Looking downstream along lands ide slope near boring 2F-92-27. (April 27, 1992)

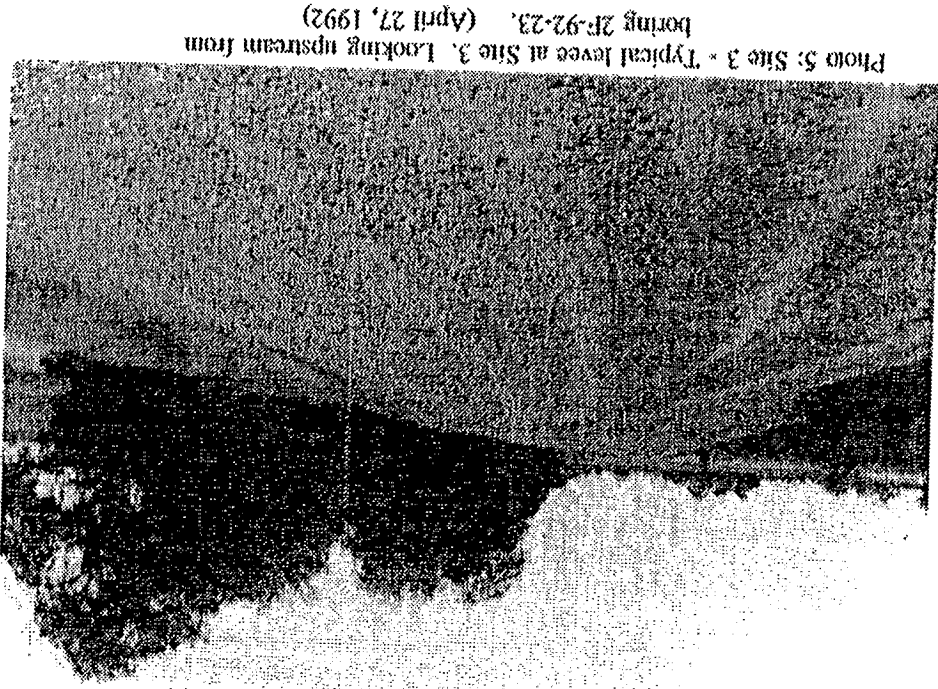
Site 3 was reported as a seepage site. Again, the levee material consists of clean sand. However, the landside slope is relatively flat at IV on 2.2H to 2.7H (Photos 5 and 6). The freeboard at this location is 6 to 9 feet. During flood conditions, the head differential between the river and the landside toe is a maximum of about 10 feet. Although seepage may occur in this area, it does not pose any significant threat to the levee stability. Therefore, no repairs are recommended at this location.

Photo 5: Site 3 - Typical levee at Site 3. Looking upstream from boring 2F-92-23. (April 27, 1992)

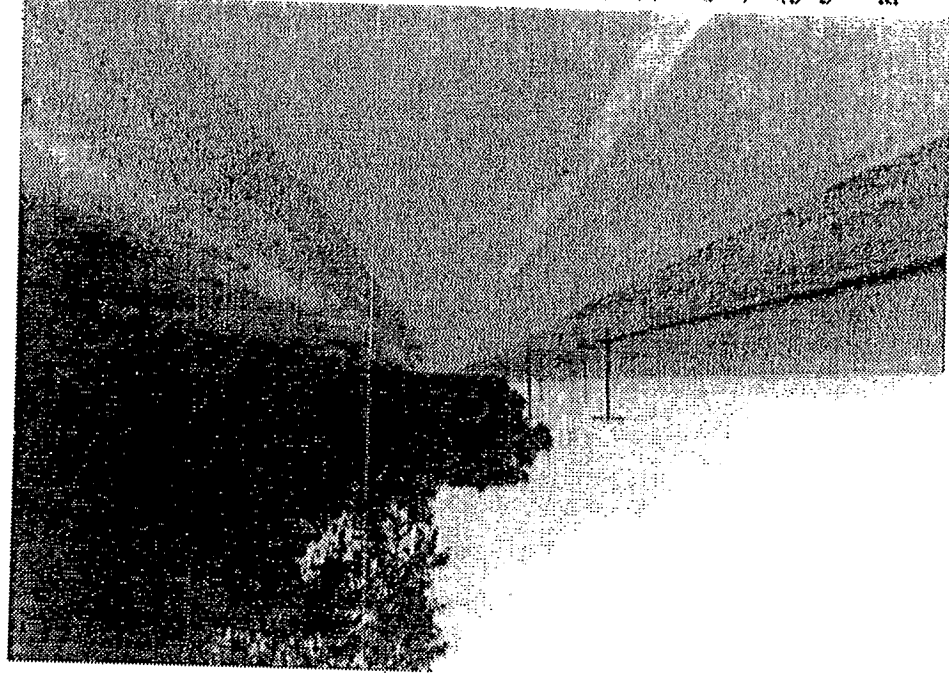
Stability analyses were performed at Site 4. The resulting minimum factor of safety was 1.42, which is above Corps criteria. However, the maximum levee height is approximately 16 feet, with a landside slope of IV on 2H to 2.2H (Photos 7 and 8). Levee and foundation soils are predominantly sand at boring location 2F-92-22. The freeboard at this location is estimated to be about five feet. During flood conditions, the head differential between the river and the landside toe is a maximum of about 11 feet. There is sufficient concern for levee stability in the vicinity of boring 2F-92-22 to warrant construction of a landside seepage/stability berm. The levee material at boring location 2F-92-20 and 2F-22-21 consists of sand, clay, and clayey sand and the levee height is lower (12 to 14 feet). Therefore, it is recommended that a seepage/stability berm (Figure A-1) be constructed in the area along boring 2F-92-22, as shown on Plate 33. The berm will improve overall stability of the levee and decrease the potential for foundation piping.

Photo 7: Site 4 - Paved highway on top of levee. Looking upstream from boring 2F-92-22. (April 27, 1992)

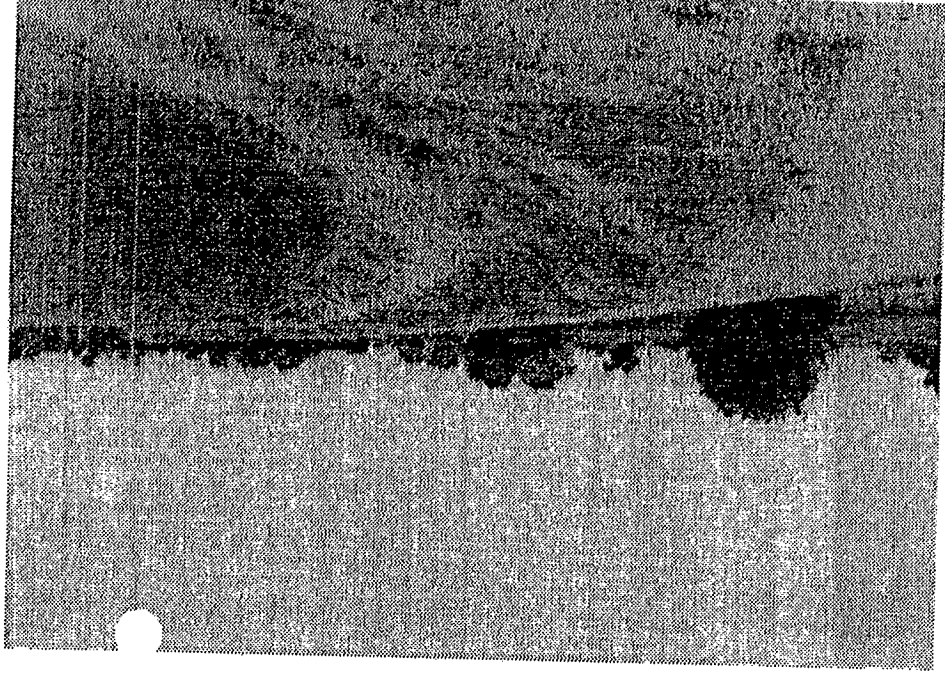
Photo 6: Site 3 - Typical lands ide slope along this site. Looking downstream near boring 2F-92-23. (April 27, 1992)

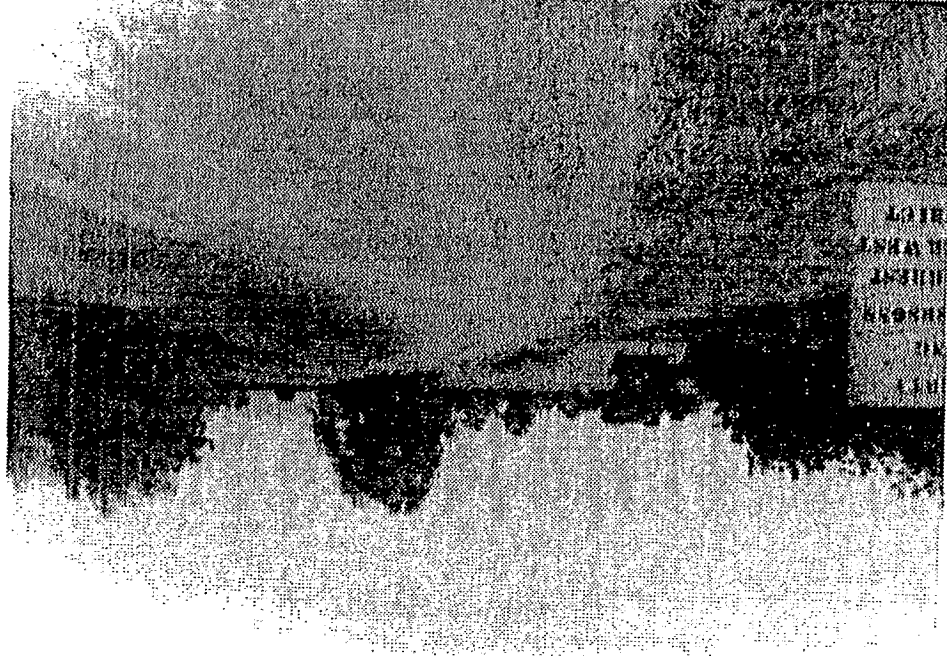
Photo 8: Site 4 - Looking upstream from boring 2F-92-21. (April 27, 1992)

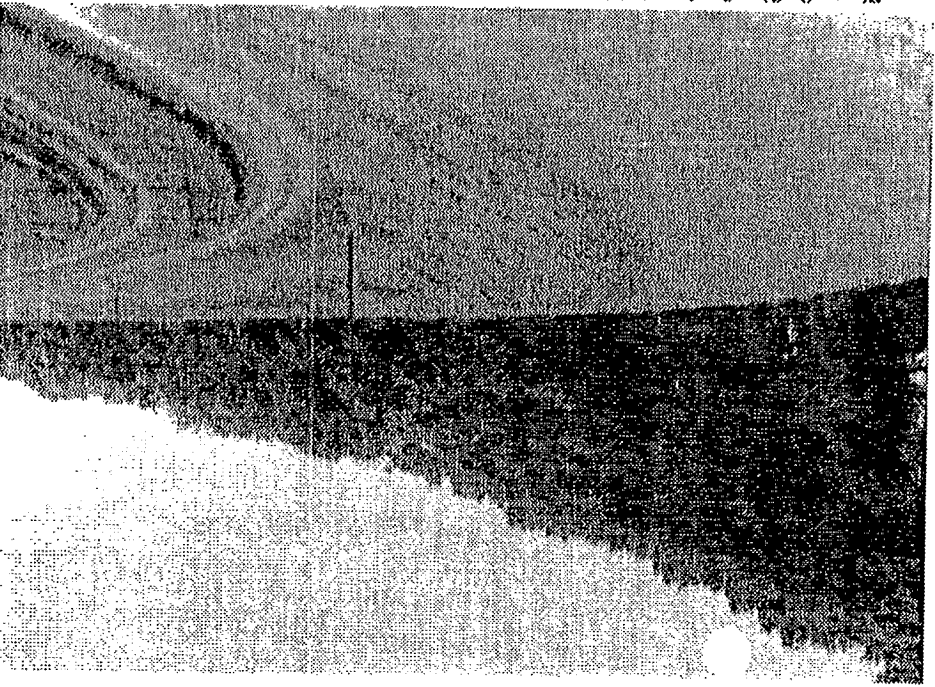
Site 5 is about 2,500 feet in length and extends from R.M. 122.5 upstream to R.M. 123 (Location, Plate 6, and Profile Plate 35). See photos 9 and 10. This is a reported seepage area. The levee soils in this area consist of clayey sand or sandy clay. The foundation materials are mostly clay and clayey sand.

Site 5 was identified as being a short reach with seepage-related problems. The levee and foundation soils along this site are primarily clay, sandy clay, and silt. During the field inspection, any indications of past seepage in this area were not apparent, and the overall appearance of this reach appears structurally sound (Photos 9 and 10). Therefore, there are no recommendations for reconstruction for this site.

Photo 9: Site 5 - Lands ide slope just downstream of boring 2F-92-19.
(April 27, 1992)

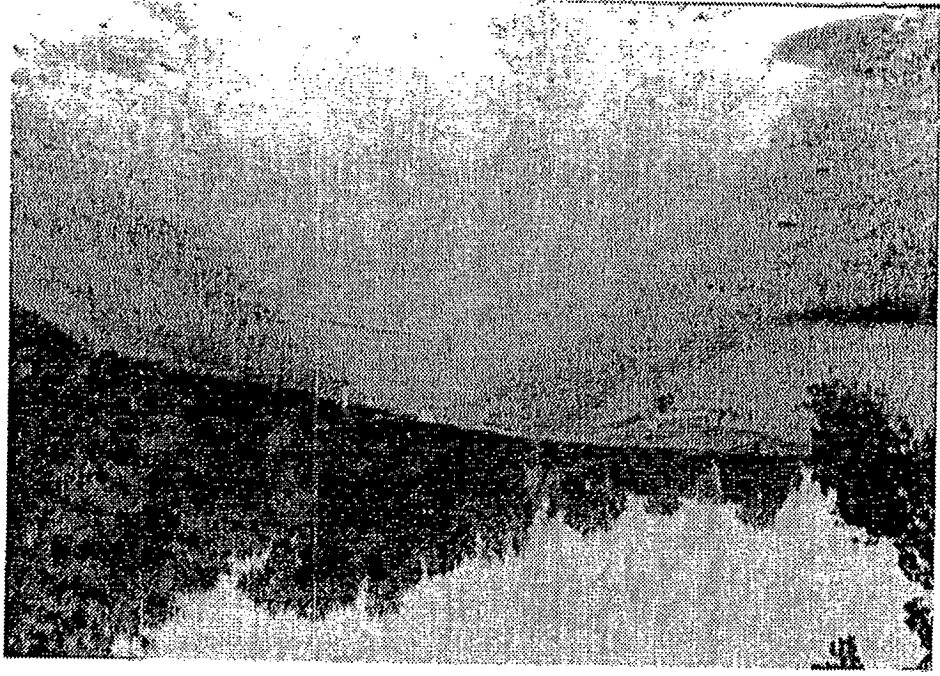
The levee soils at Site 9 are predominantly loose and clean sand. The landside slope is relatively flat at IV on 2.4H to 2.7H at boring locations 2F-92-17, and 2F-92-18 (Photos 11 and 12). During flood conditions, the head differential between the river and the landside toe is only about 8 feet. No signs of slope instability were noted during the field inspection. Stability analyses were performed, and the resulting factor of safety was 1.52, which is above Corps criteria of 1.4. No reconstruction is recommended at this location.

Photo 11: Site 9 - Typical levee along this reach. Looking upstream
from boring 2F-92-18. (April 27, 1992)

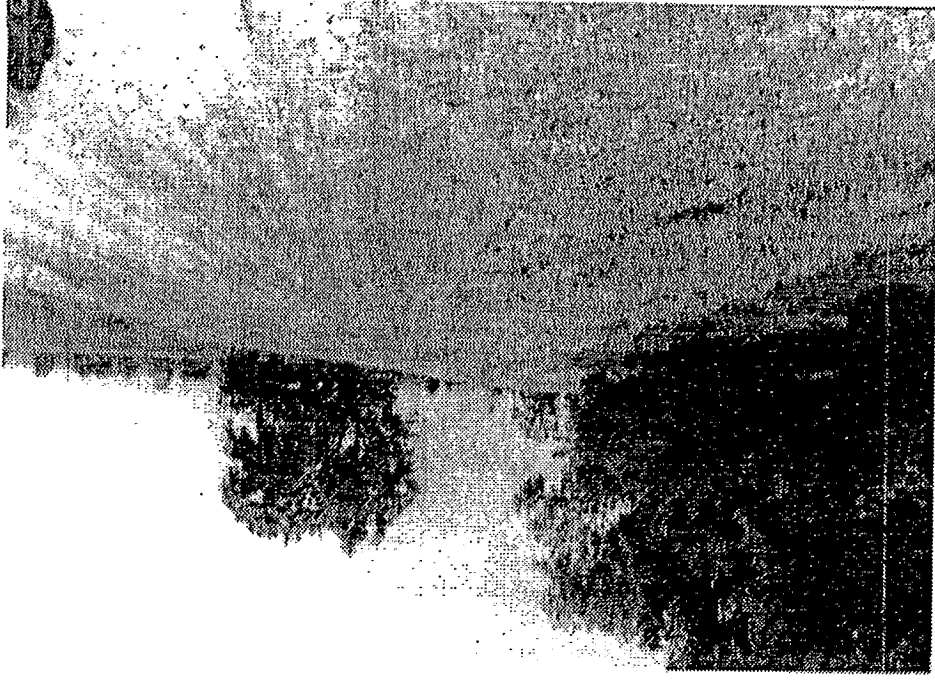
Photo 12: Site 9 - Levee is relatively low along this site. Looking downstream
from boring 2F-92-18. (April 28, 1992)

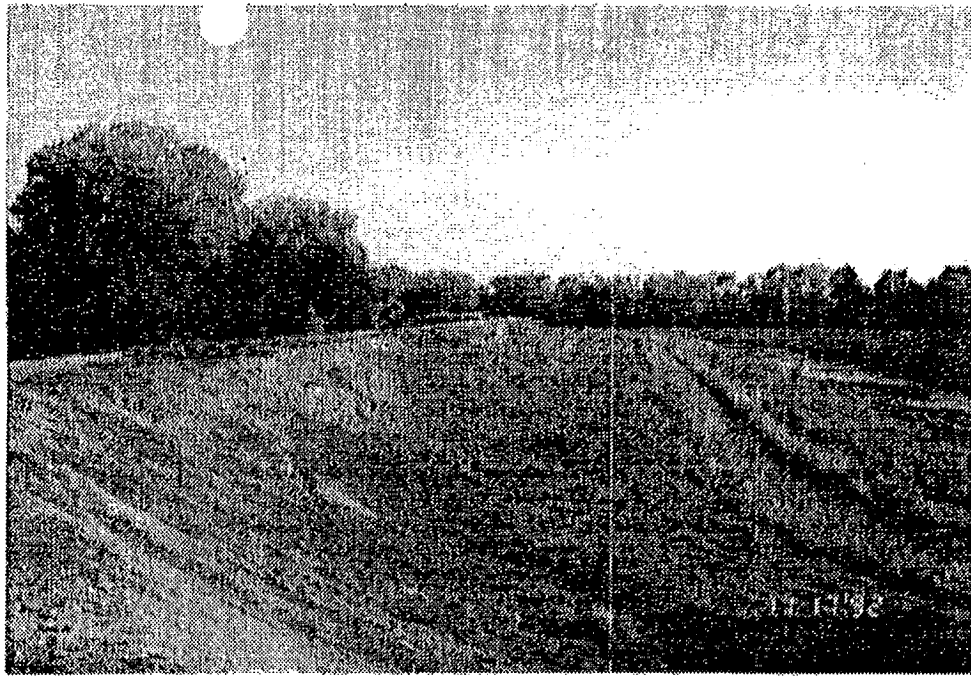
Photo 13: Site 10 - An irrigation ditch running along the landside toe. Looking downstream near boring 2F-92-14 (Nov 17, 1992)

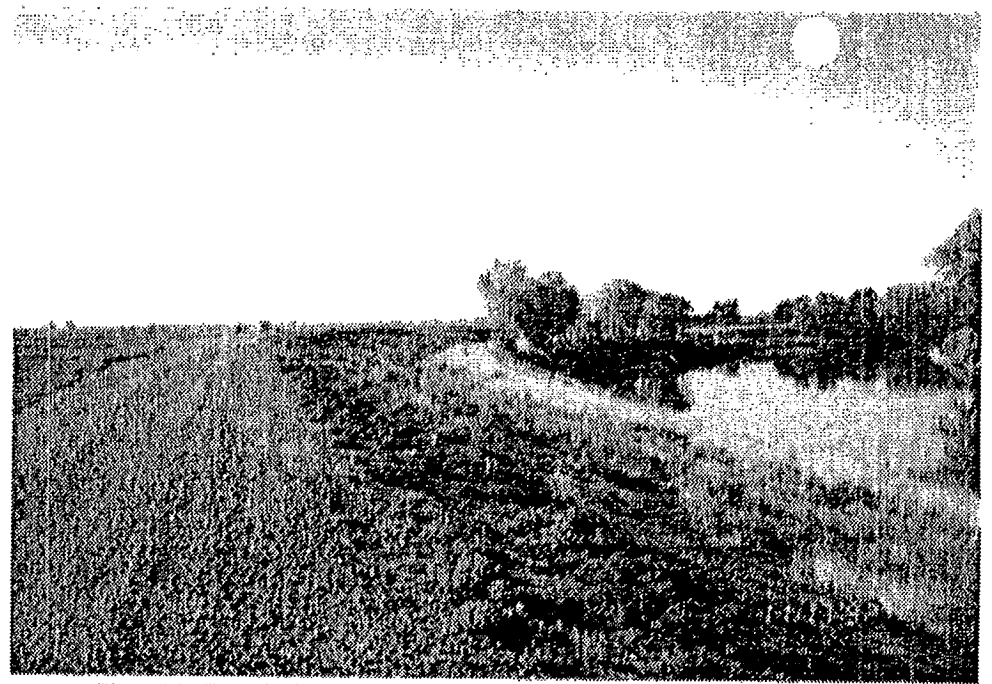
Photo 14: Site 10 - Looking upstream along waterside slope from boring 2F-92-14. (Nov. 17, 1992)

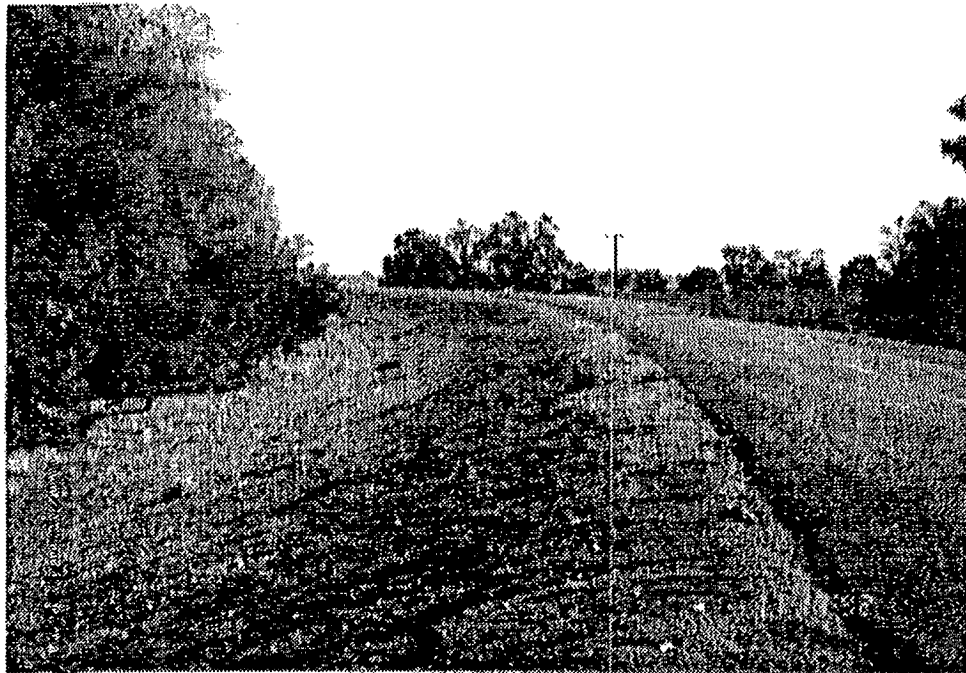
The levee between Site 11 to Site 12 is considered highly susceptible to damage during floods. Seepage and sand boils along the landside toe during the 1986 flood indicates a potentially unstable condition. The maximum height of levee along this area is approximately 19 feet, with a landside slope of IV on 1.8H to 2.5H (Photos 15 through 18). As indicated on the levee profile on Plate 43, the levee and foundation soils are predominantly sand. Therefore, it

Photo 15: Site 11 - Paved highway on top of levee. Looking downstream along waterside slope near boring 2F-92-11. (Nov 17, 1992)

is recommended that a landside seepage/stabilizing berm be constructed (See Figure A-1). The berm will not reduce the overall quantity of seepage, but it will improve the stability of the levee and decrease the potential for piping of foundation sand.

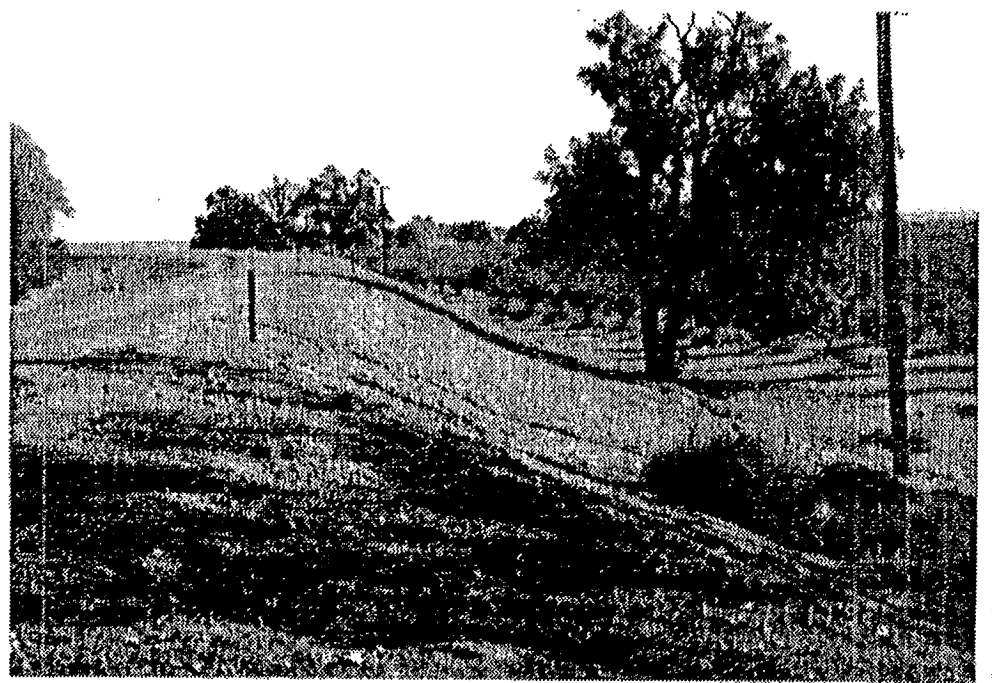
Photo 16: Site 11 - Looking downstream along landside slope near boring 2F-92-11. (Nov 17, 1992)

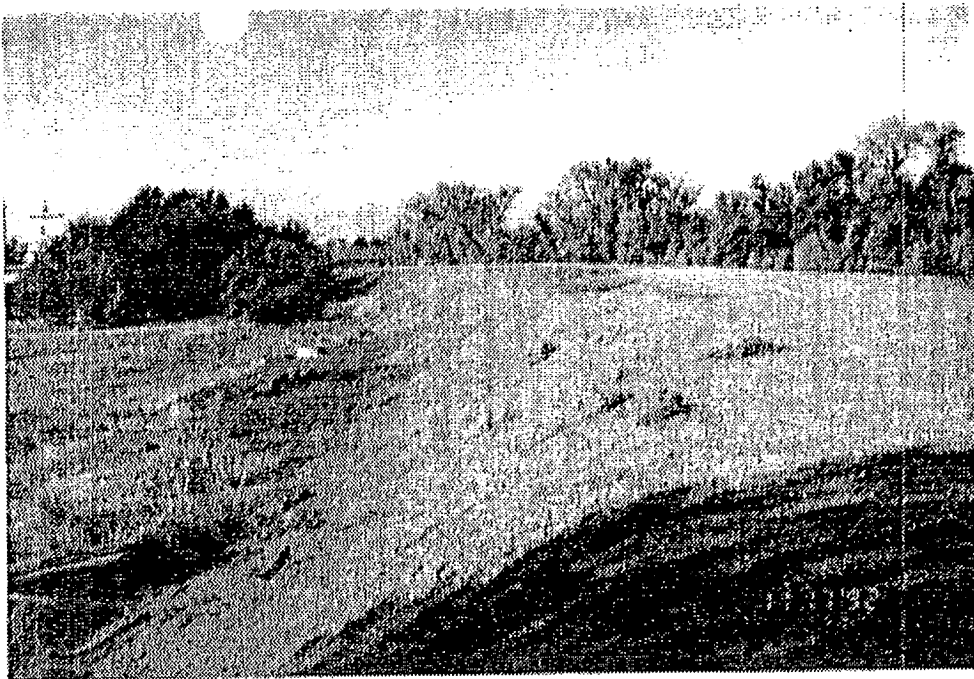
Photo 17: Site 12 - Steep landside slope just upstream of boring 2F-92-9. (Nov 17, 1992)

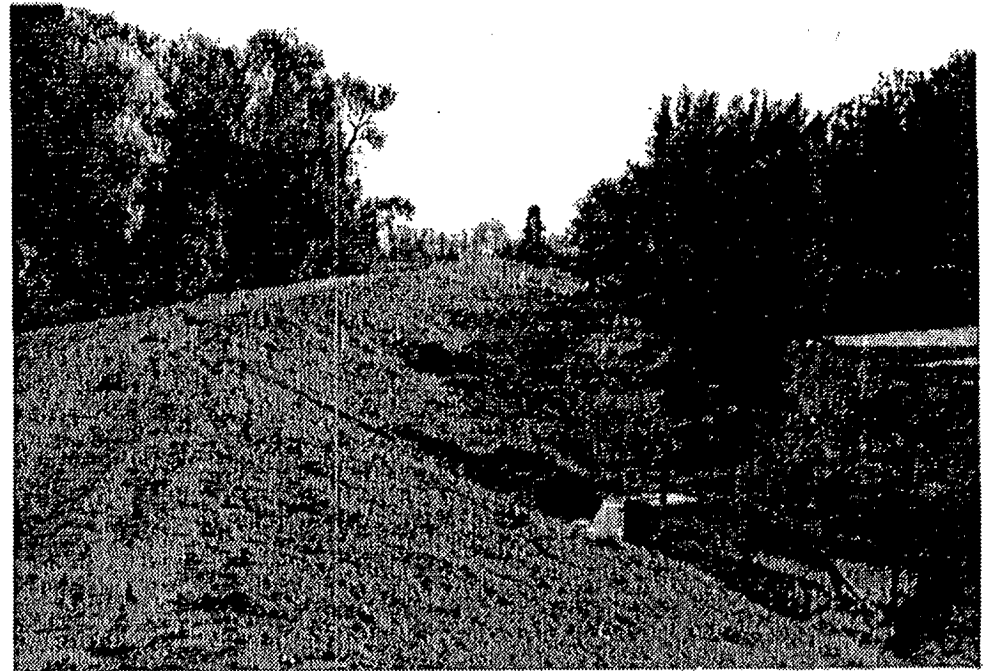
Photo 18: Site 12 - Looking downstream along landside slope from boring 2F-92-9. (Nov. 17, 1992)

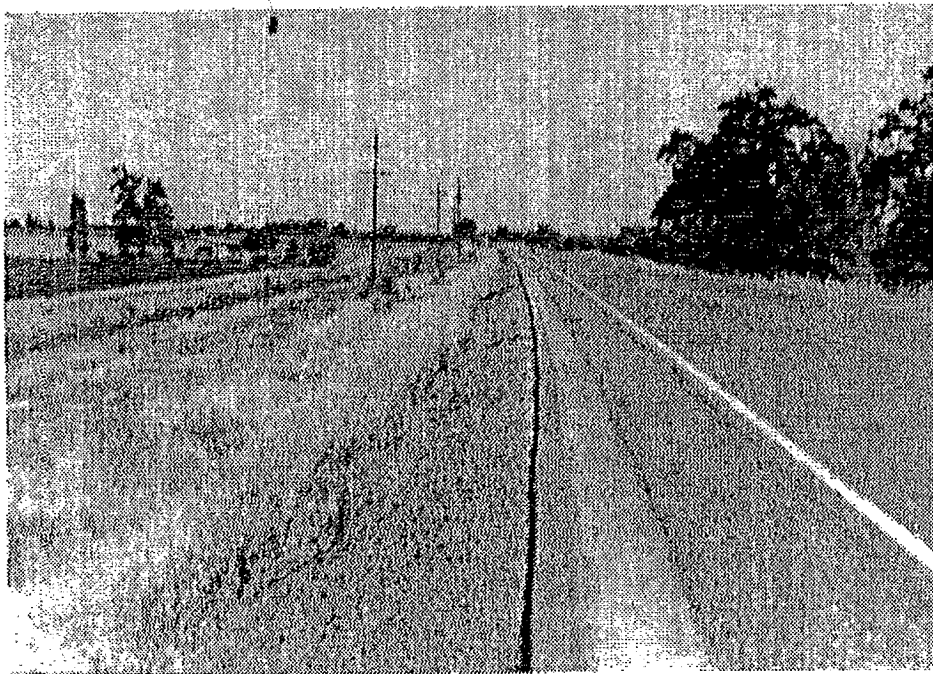
Site 16 is a location where seepage flows into a drainage ditch adjacent to the levee toe. This reach of levee is a paved highway with a very large crown width, approximately 40 feet (Photo 19). The levee and foundation material consists mostly of clay, and there does not appear to be a high potential for piping. It is likely that the drainage ditch intercepts some seepage during high water. No repairs are recommended at this site.

Photo 19: Site 16 - Paved highway on top of levee and an irrigation ditch running parallel to the landside toe throughout this site. (May 21, 1992)

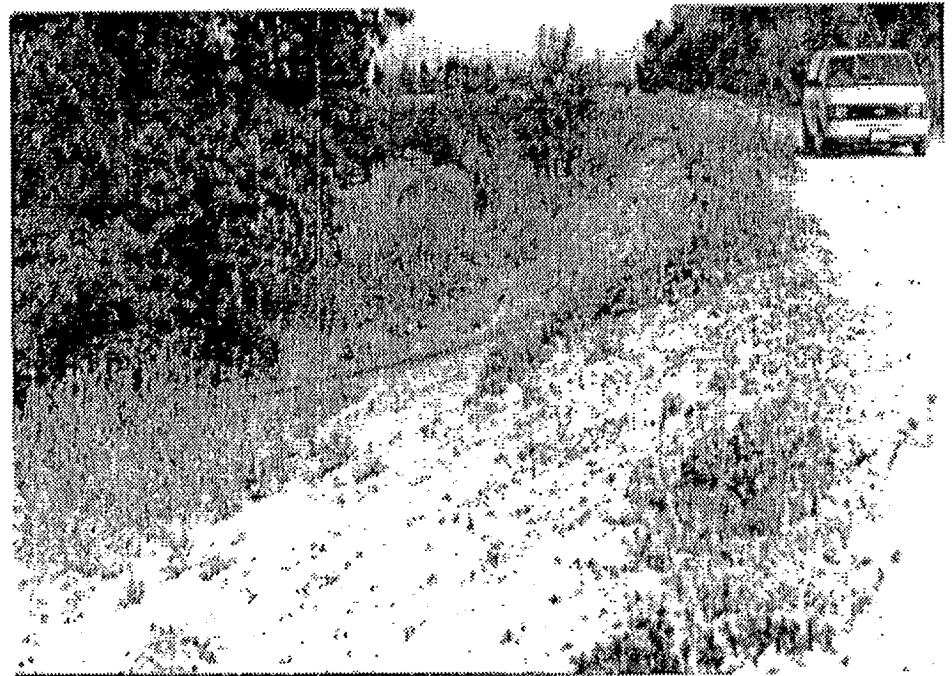
Approximately 600 feet north of Site 16, past seepage has been reported adjacent to the 4-inch-diameter cast iron pipe through the levee (Photo 20). The pipe is highly corroded and penetrates the levee at a point below the design flood level. The pipe was apparently used in past years for irrigation. It appeared to be abandoned. For several reasons, including the susceptibility of the levee soils to seepage and piping and the deteriorated condition of the pipe, the pipe should be removed and the levee soils recompacted adjacent to the excavation created during removal of the pipe.

Photo 20: North of Site 16 - 4 inches diameter cast iron pipe through the levee. (May 21, 1992)

North of Site 16, seepage has been reported adjacent to the 4-inch diameter cast iron pipe through the levee (Photo 20). The pipe should be removed and the levee recompacted with native material. It is recommended that this measure be undertaken by the Glenn County Levee District No. 2.

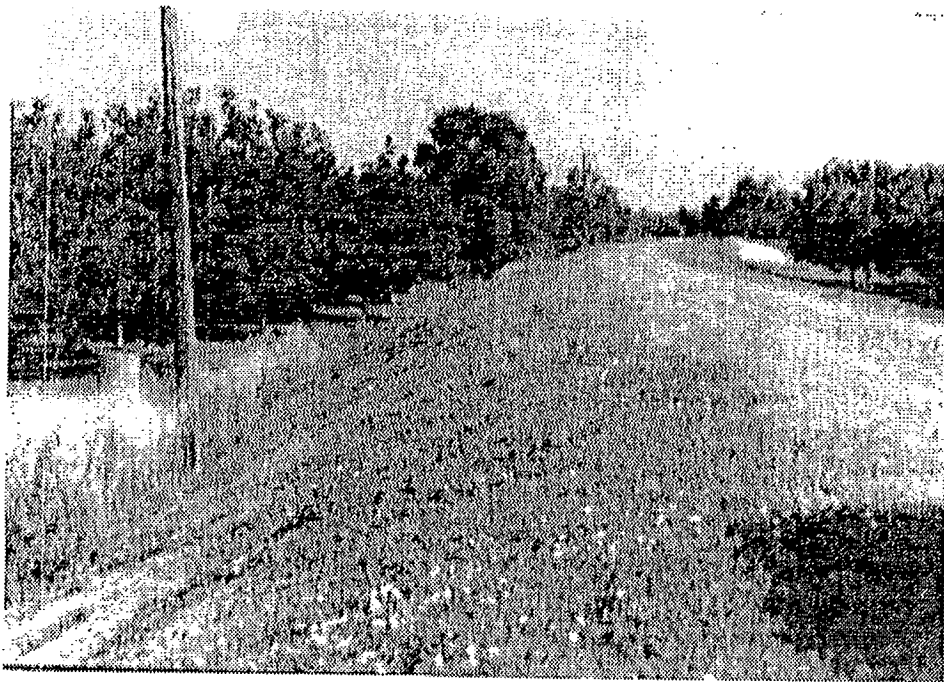
Photo 21: Site 19 - Looking upstream along the lands ide slope from boring 2F-92-1. (May 21, 1992)

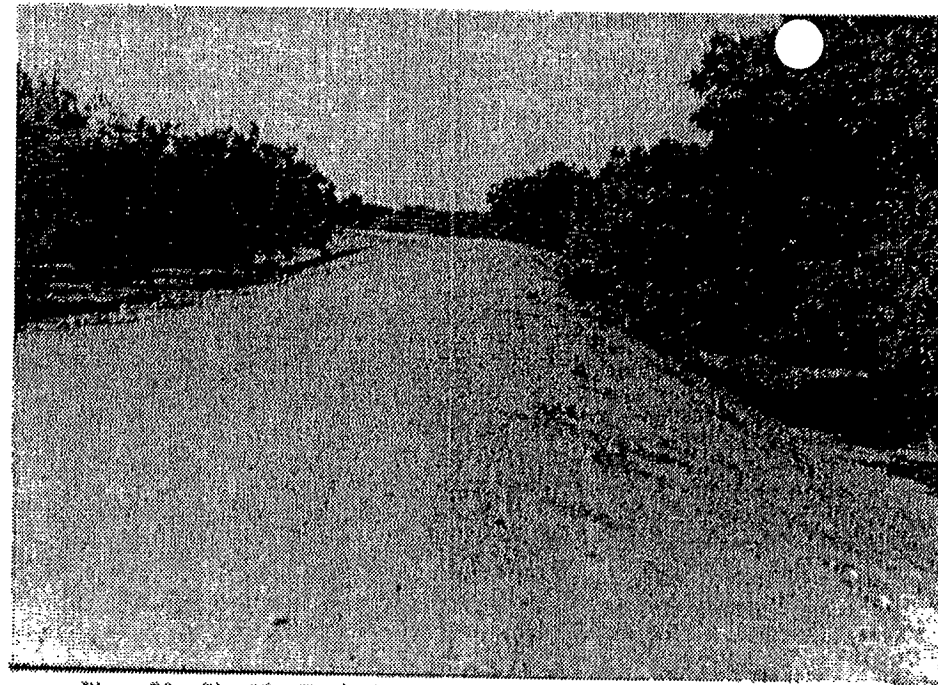
Photo 22: Site 19 - Typical levee along this site. Looking downstream from boring 2F-92-2. (May 21, 1992)

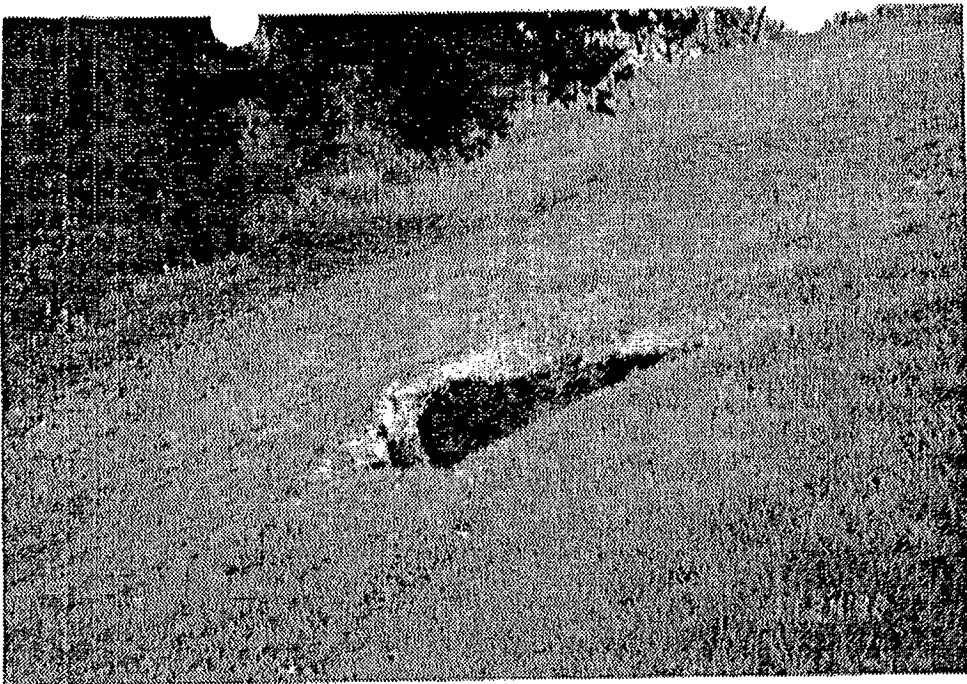
Photo 24: Approx. 1600 ft. north of Site 14 - A very large depression on the riverside slope near levee mile 7.1. (Nov 24, 1992)

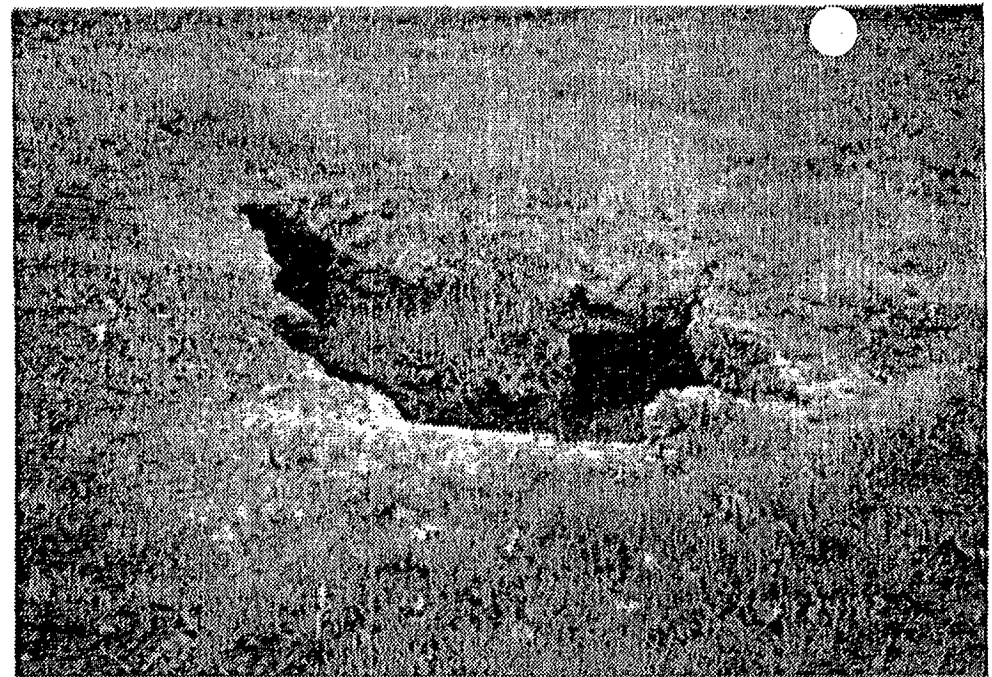
Photo 25: Approx. 1600 ft. north of Site 14 - Different view of the depression. (Nov. 24, 1992)

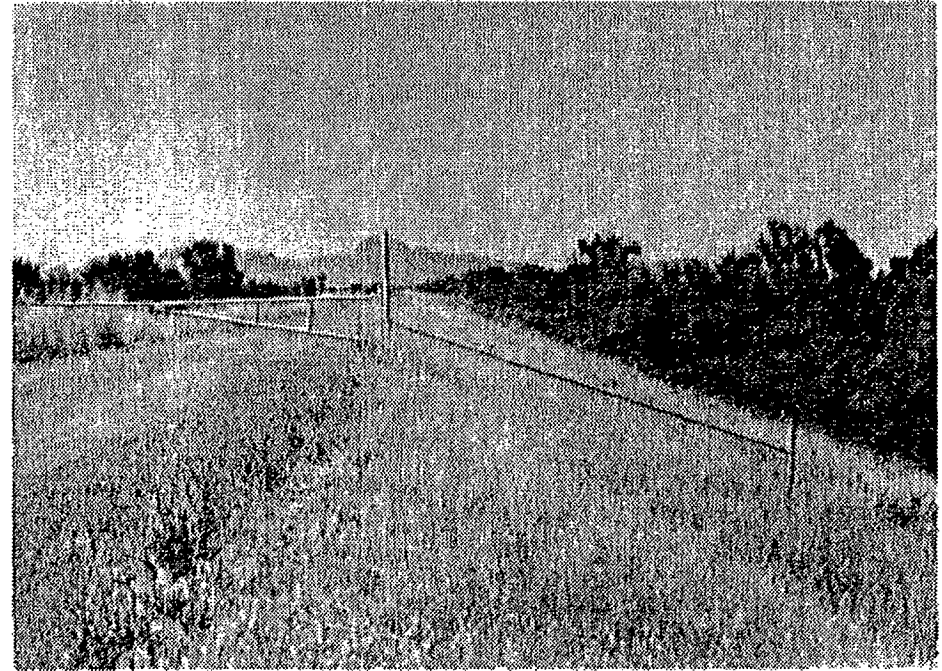
Photo 27: Site 8 - Looking upstream along waterside slope. (May 21, 1992)

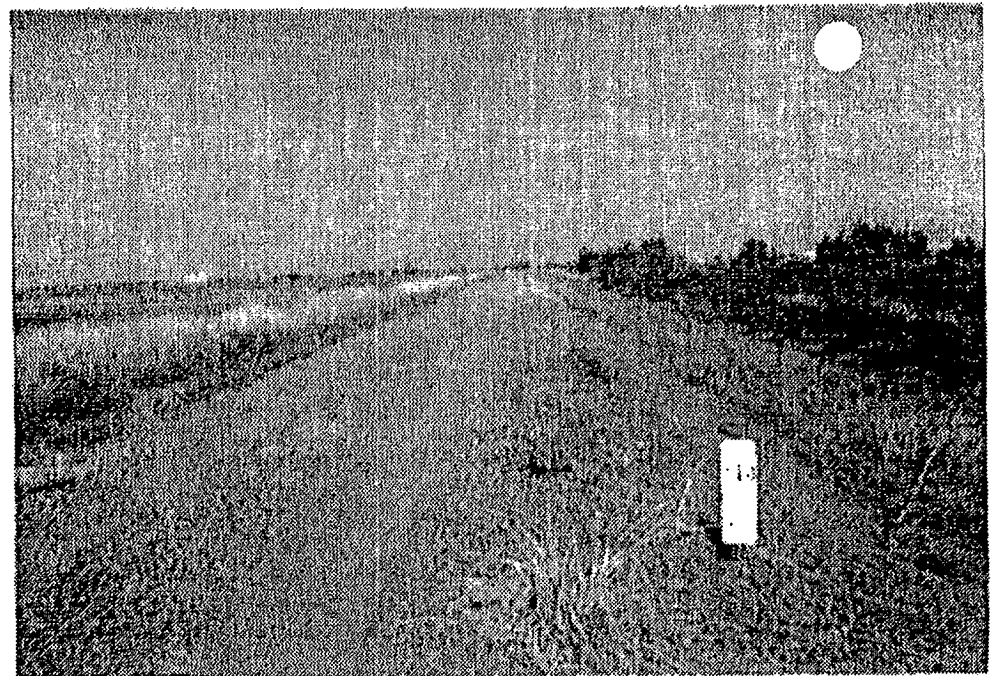
Photo 29: Cherokee Canal - Typical North bank levee
(Oct 27 1992)

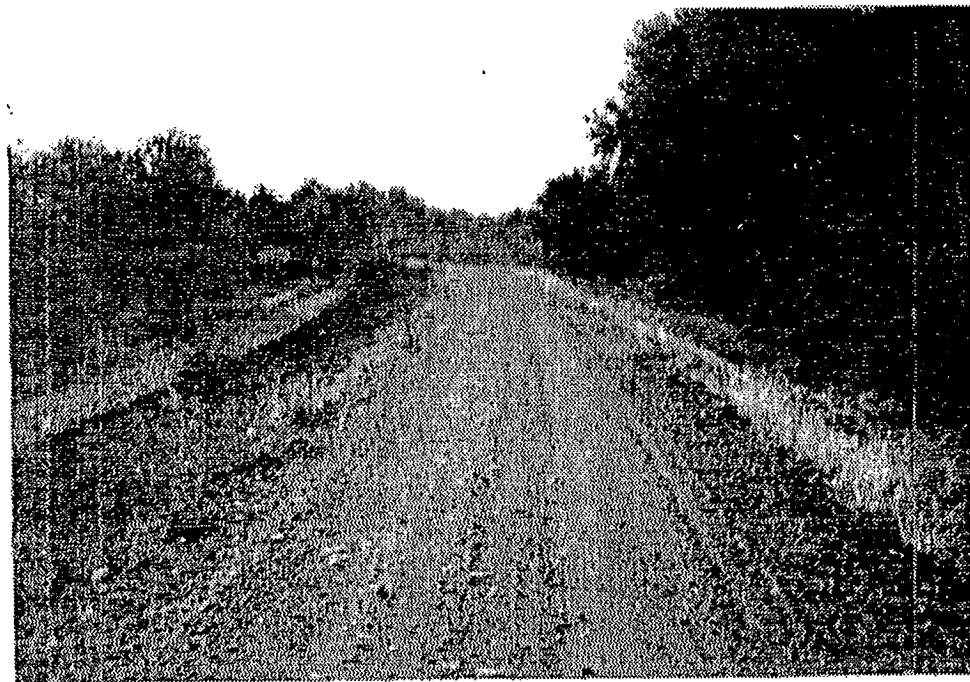
Photo 30: Typical levee at Butte Creek. Looking downstream along
North bank levee. (Oct 27, 1992)

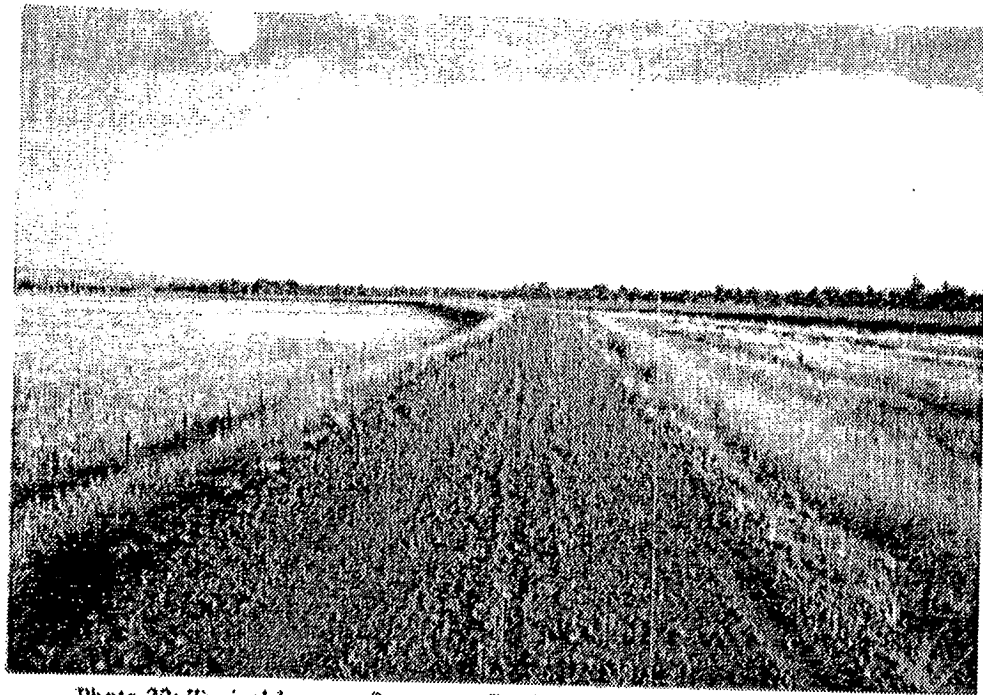
Photo 32: Typical levee at Sycamore Creek. Looking upstream along North bank levee. (Oct 26, 1992)

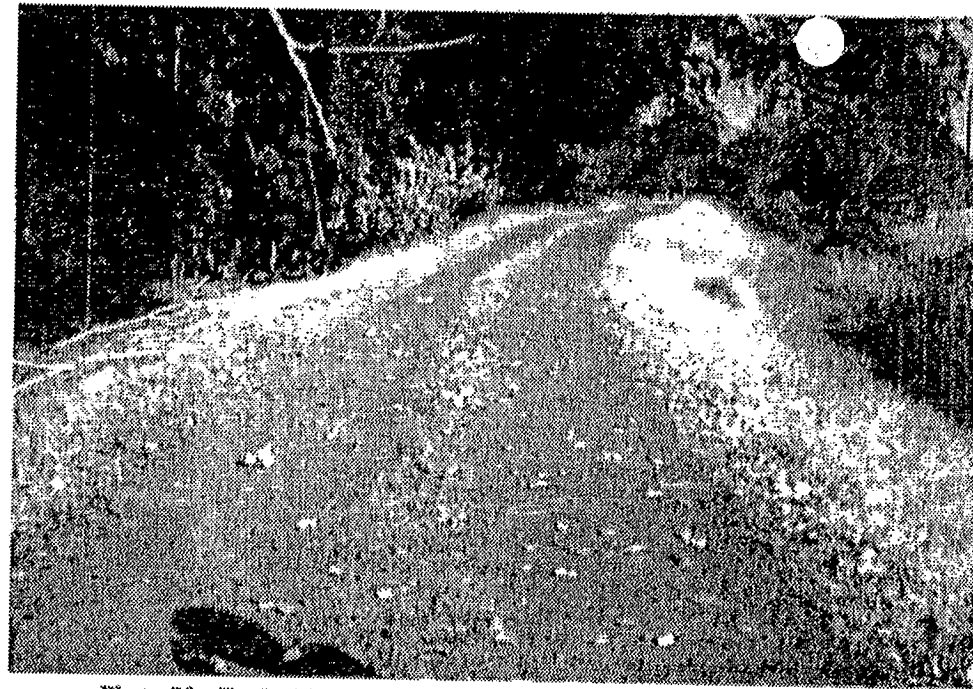
Photo 33: Typical levee of Deer Creek. Looking downstream along South bank levee. (Oct 26, 1992)

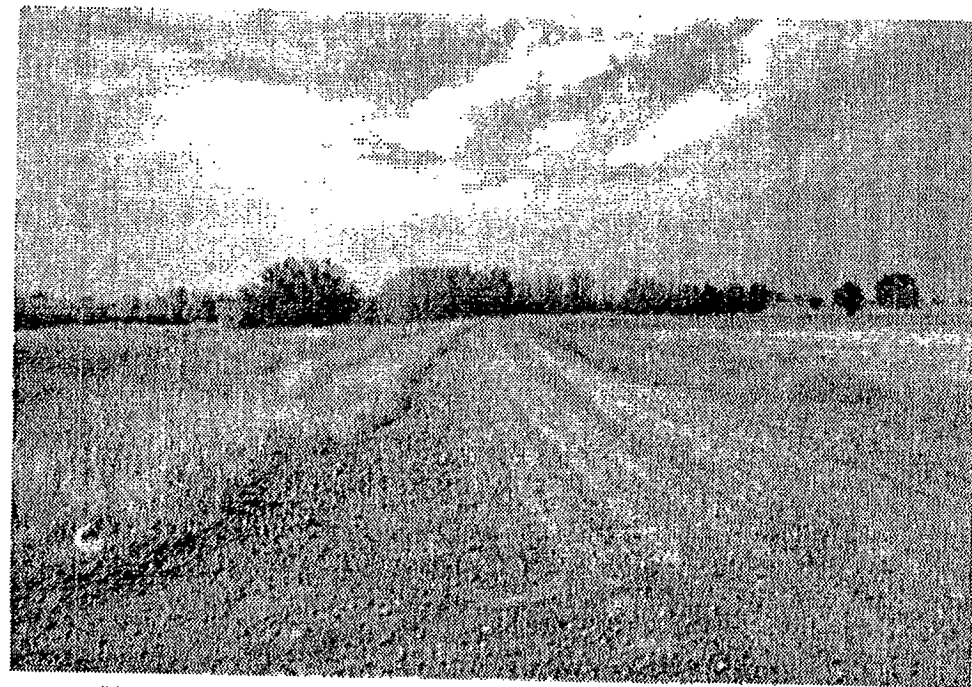
Photo 35: Elder Creek - Typical North bank levee (Oct 27 1992)
